3843 GILPIN ST

## Property ID # 2305 / 3843 Gilpin Street

VASQUEZ BOULEVARD AND I-70

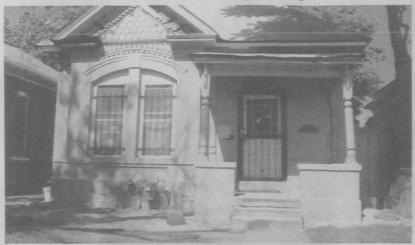
East exposure of house

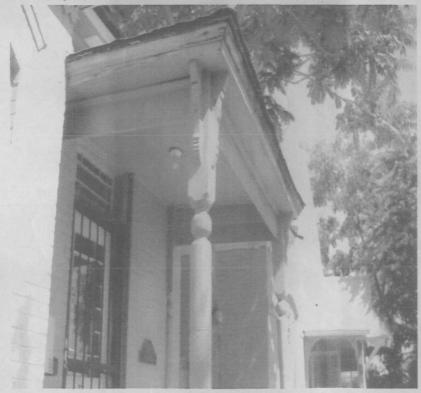
Wood trim above porch contains peeling lead paint

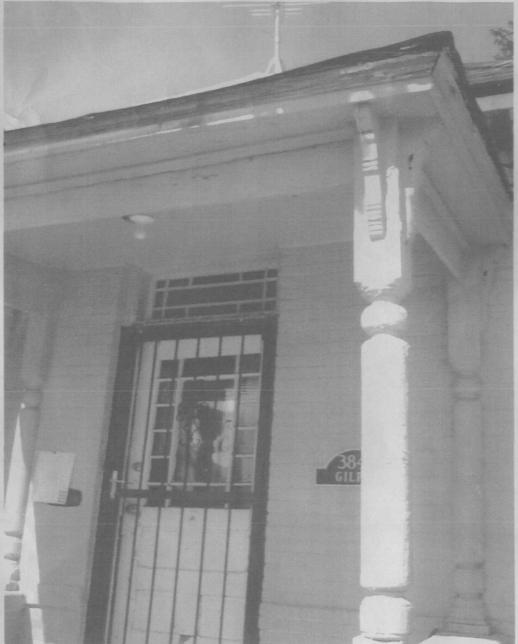
Wood porch columns & trim contain peeling lead paint

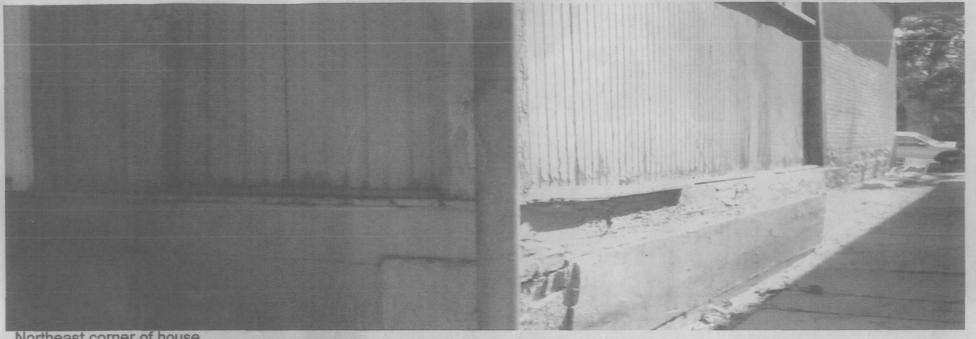
Property # 2305: Wood siding on northeast corner of house contains peeling lead paint

Northeast corner of house

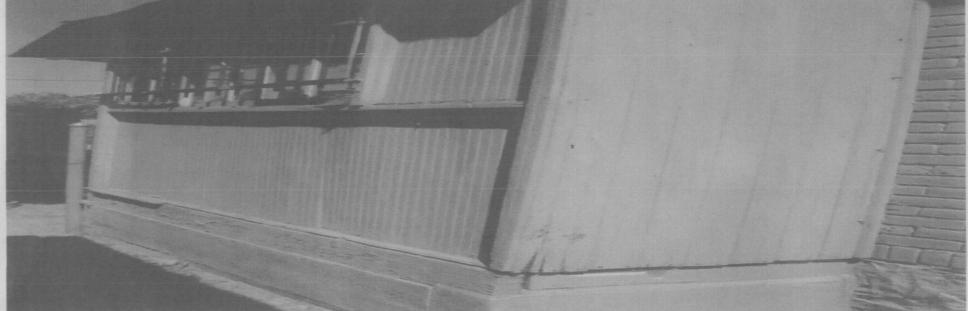
East exposure of wood siding on house

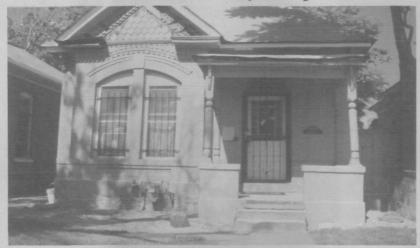
East exposure of house

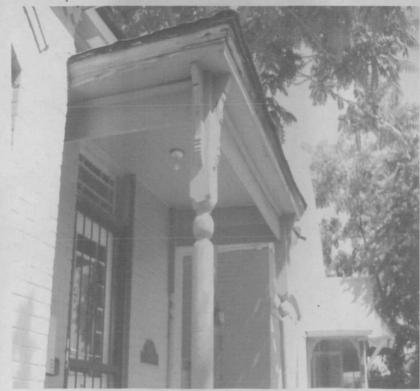
Wood trim above porch contains peeling lead paint

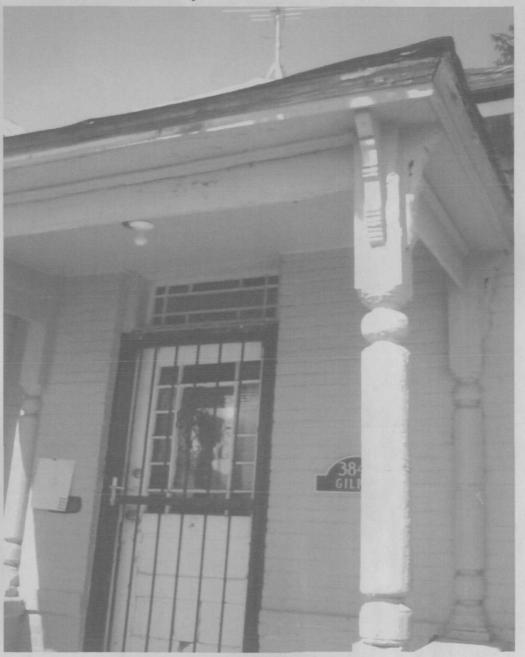
Wood porch columns & trim contain peeling lead paint

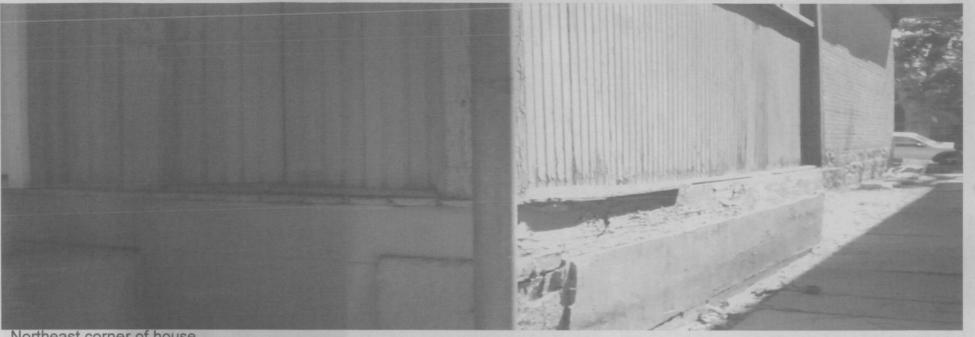
Property # 2305: Wood siding on northeast corner of house contains peeling lead paint

Northeast corner of house

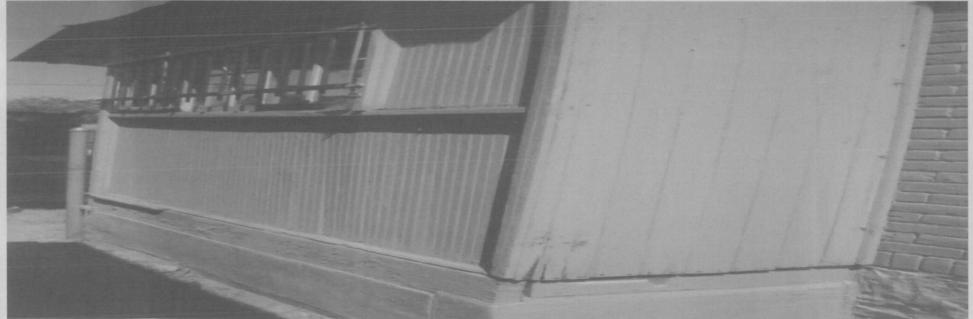
East exposure of wood siding on house
